DEPARTMENT OF TRANSPORTATION

Quality Assurance and Source Inspection

Contract #: 04-0120F4Cty: SF/ALA Rte: 80 PM: 13.2/13.9File #: 69.28**WELDING INSPECTION REPORT****Resident Engineer:**Pursell, Gary**Address:** 333 Burma Road**City:** Oakland, CA 94607**Report No:** WIR-011688**Date Inspected:** 26-Jan-2010**Project Name:** SAS Superstructure**OSM Arrival Time:** 645**Prime Contractor:** American Bridge/Fluor Enterprises, a JV**OSM Departure Time:** 1845**Contractor:** Zhenhua Port Machinery Company, Ltd (ZPMC), Changxing Island **Location:** Shanghai, China**CWI Name:** Liu Fawen**CWI Present:** Yes No**Inspected CWI report:** Yes No N/A**Rod Oven in Use:** Yes No N/A**Electrode to specification:** Yes No N/A**Weld Procedures Followed:** Yes No N/A**Qualified Welders:** Yes No N/A**Verified Joint Fit-up:** Yes No N/A**Approved Drawings:** Yes No N/A**Approved WPS:** Yes No N/A**Delayed / Cancelled:** Yes No N/A**Bridge No:** 34-0006**Component:** Orthotropic Box Girder (OBG) Components**Summary of Items Observed:**

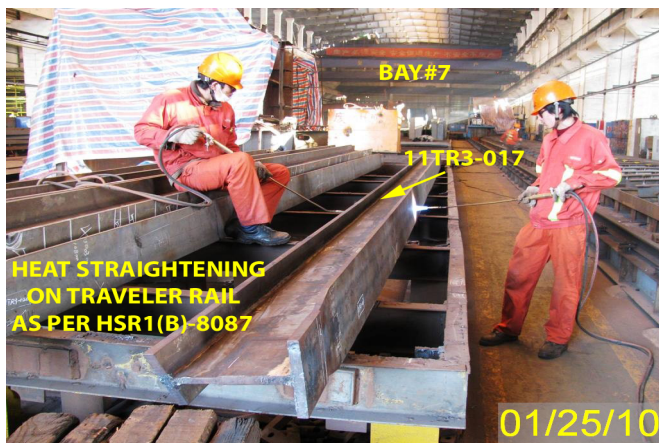
Heat Straightening being performed on OBG Traveler Rail identified as 11TR3 – 017 by oxy-acetylene flame method to remove the distortion that occurred after welding. ZPMC Quality Control (QC) Inspector is identified as Zhong Dian Xing present at the location. This activity appeared to comply with the Heat Straightening Report # HSR1 (B) – 8087. (See attached photo)
